Manhole Inspection Summary

Manhole # S47G2_001MH

Insp Date: **1/22/08 9:38 AM**

Location Address: **4501 Curtis Ave.**

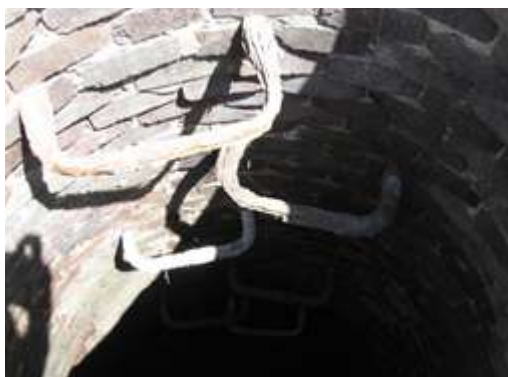
Count: **10** Missing: **0** ☒ **Corroded**

Steps

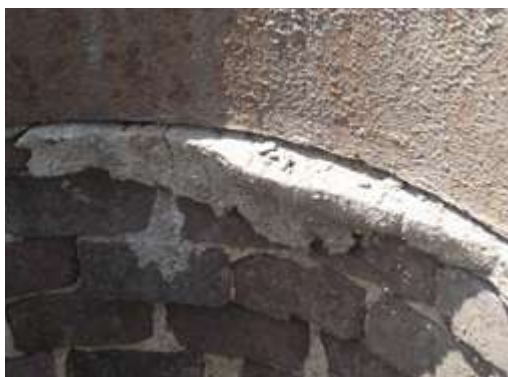
Defect 1

Infiltration: ☐ None ☒ **Joint** ☐ Cracks ☒ **Mortar** ☐ Roots ☐ Wall

Chimney infiltration

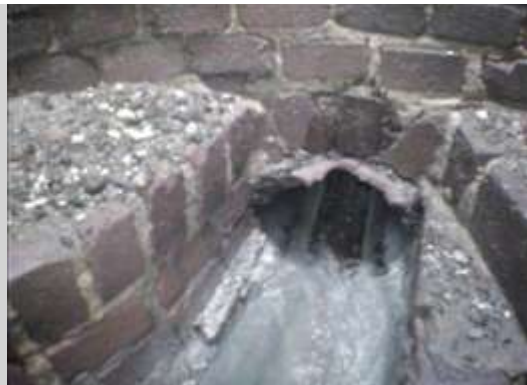
4 O'Clock Inflow

8 in. Circular Gravity Sewer
Pipe In @ 4 O'Clock

Pipe Height: **8.4** (in.) Rod and Bar (Angled)
Pipe Material: **Clay** ☐ Pipe Lined
Invert Depth: **16.16** (ft.) Flow Characteristics: **Fast**
Deposits: ☒ None ☐ Mud ☐ Sludge ☐ Debris ☐ Grease
Silt Depth: (in.) Deposits Extent:
Infiltration: **None** Pipe Seal Cond: **Broken**
